**DATE:** November 20, 2024

**PROJECT:** **Clerestory Window Rehabilitation**  
St. Andrew Catholic Church  
Channelview, TX 77530-35111

**AESTIMO PROJECT NO:** 245286-02

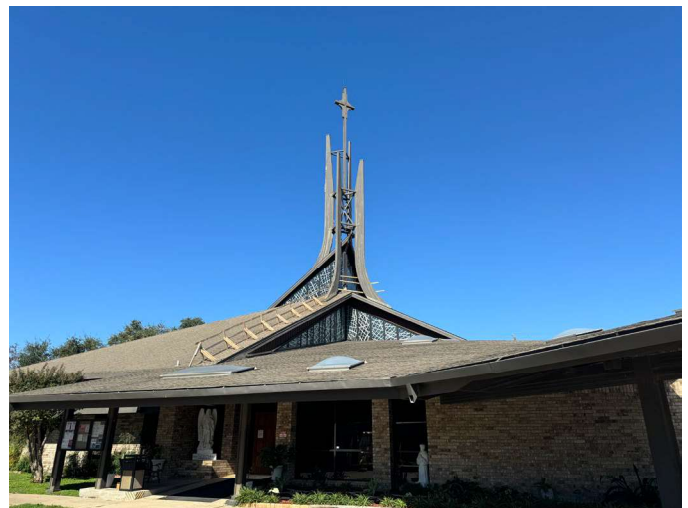
**Photograph 1.** Overview of the clerestory windows, from the southeast. Note that the wood guardrail and toe boards are still on the roof, providing access to the upper-level windows. It is believed that these temporary safety measures will remain in place until the steeple rehabilitation work is completed.

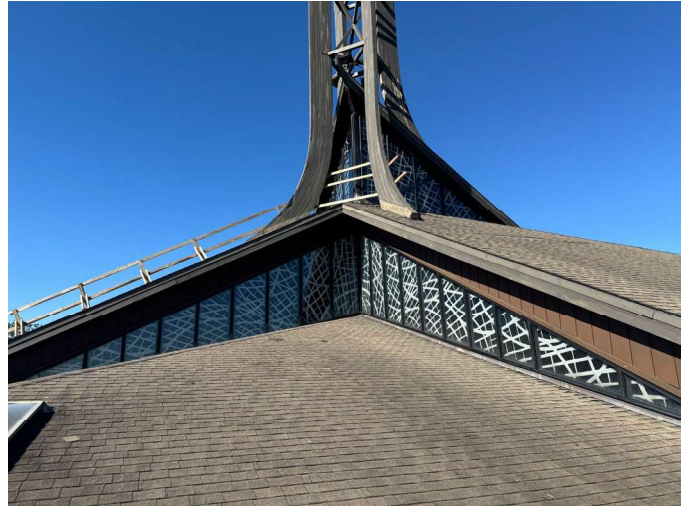
**Photograph 2.** Overview of the lower clerestory windows. The work on these windows appears to be complete and in conformance with industry standards.

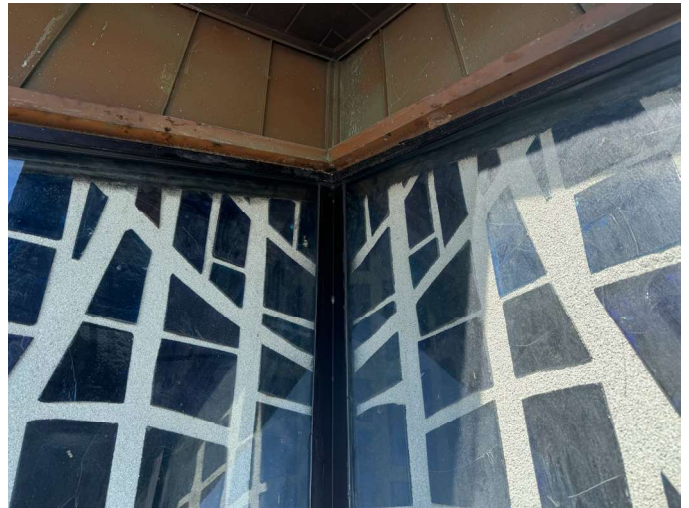
**Photograph 3.** The inside corner protective glass has been installed. A prefinished break metal has been sealed to the inside corner, closing the previously existing gap. The installation appears to be good and in conformance with accepted industry standards.

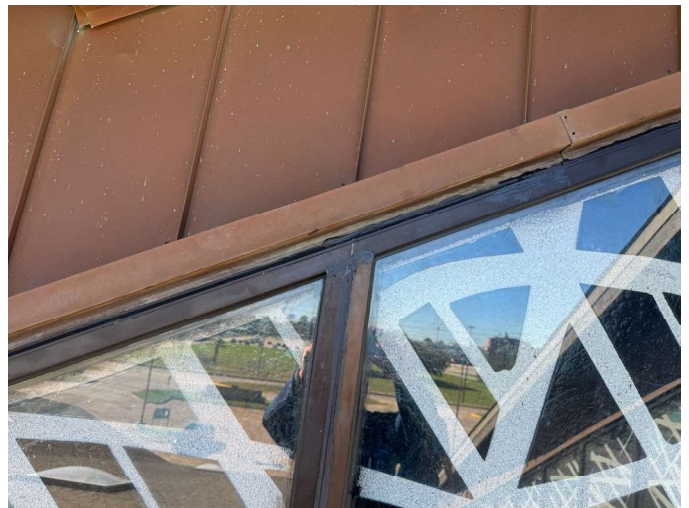
**Photograph 4.** Sealant has been installed around the perimeter of the safety glass frames on the lower clerestory windows, as well as over open framing joints. The installation generally appears to be good.

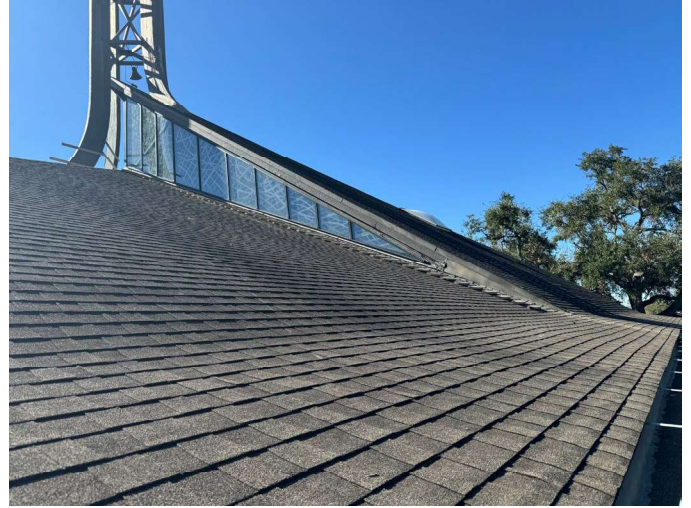
**Photograph 5.** Overview of the north upper clerestory windows at St. Andrew's.

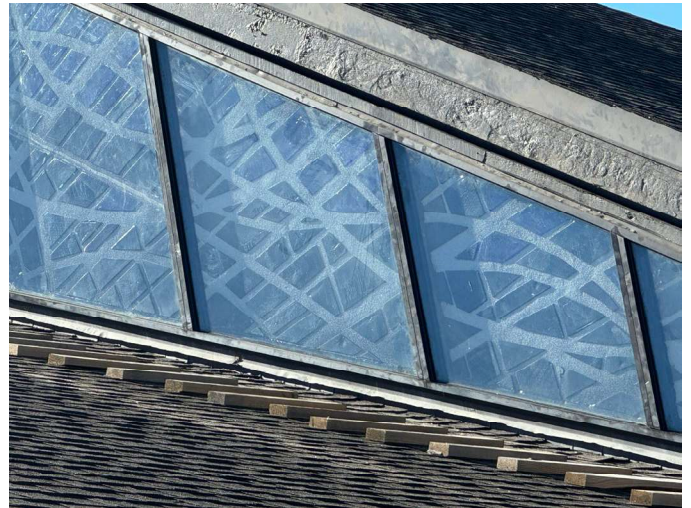
**Photograph 6.** Close-up view of windows on the north upper clerestory. The glass on this section of windows does not appear to have been properly cleaned. Note the streaks that are apparent on the glass.

In summary, the waterproofing work appears to be substantially complete and in conformance with accepted industry standards; however, minor repairs previously mentioned remain incomplete. It is recommended that Binswanger complete the remaining work noted above for the project to be considered final and complete.

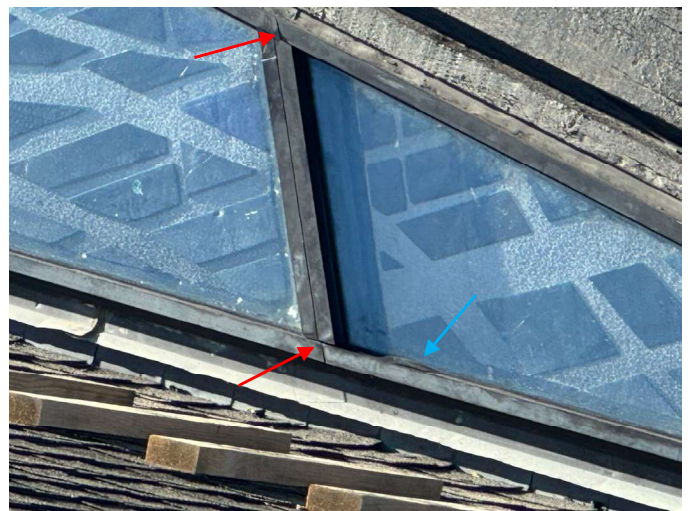
**Photograph 7.** Joints in the protective glass frame on the north upper clerestory do not appear to have been sealed (red arrows). In addition, the gasket along the bottom of the protective glass frame does not appear to be properly seated (blue arrow). Streaks and debris on the glass are also apparent in this photograph.

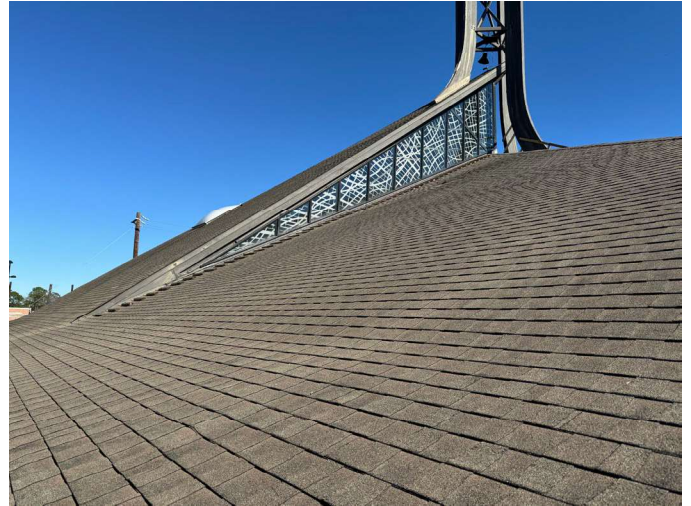
**Photograph 8.** Overview of the west upper clerestory window at St. Andrew's.

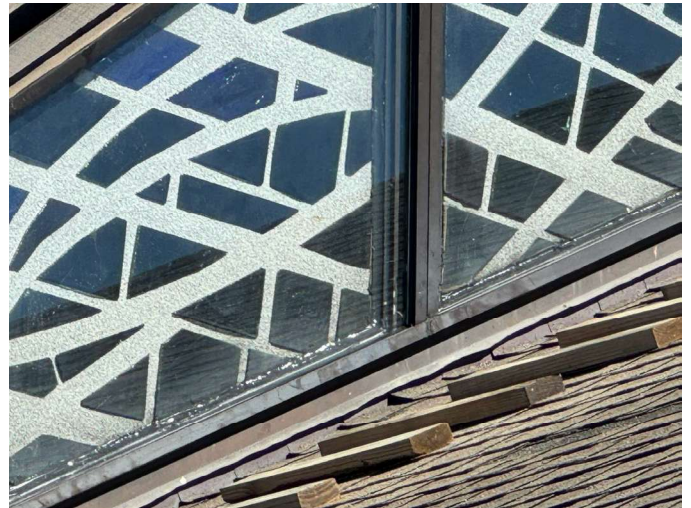
**Photograph 9.** Typical sealant installation on the west upper clerestory windows. The installation is not as cleanly installed as the lower clerestory windows, but generally appears to be functional.

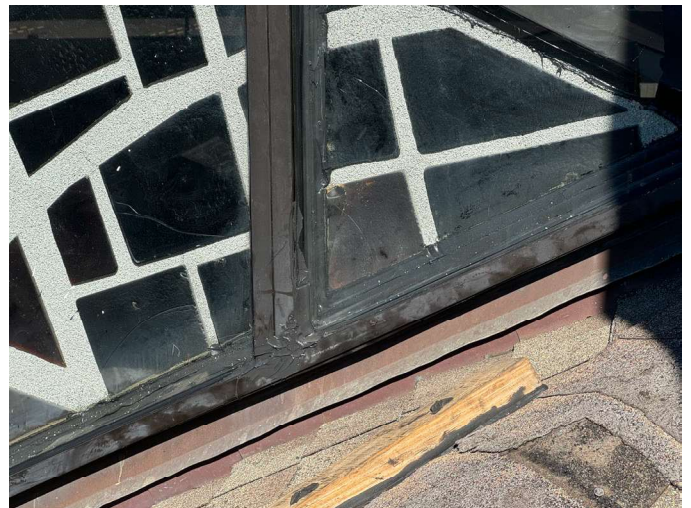
**Photograph 10.** Most of the protective glass frame joints have been sealed on the west upper clerestory; however, the sealant was not cleanly applied at all locations

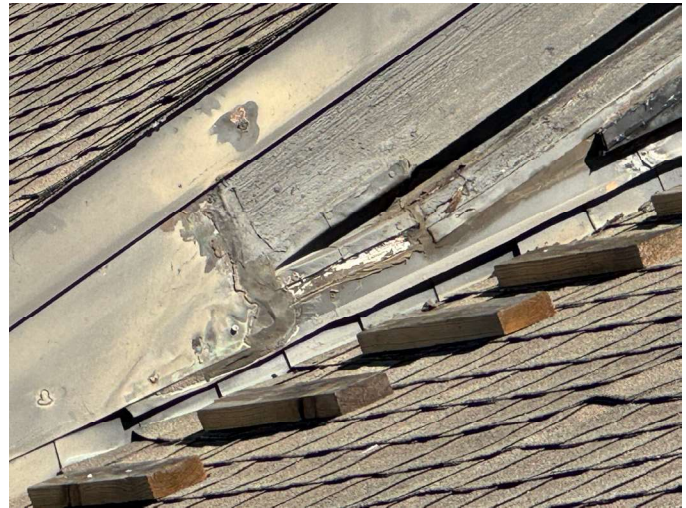
**Photograph 11.** View of a typical rake flashing that remains to be addressed at the base of the west upper clerestory. Similar conditions also exist at the base of the north lower clerestory, the north upper clerestory and the west lower clerestory.

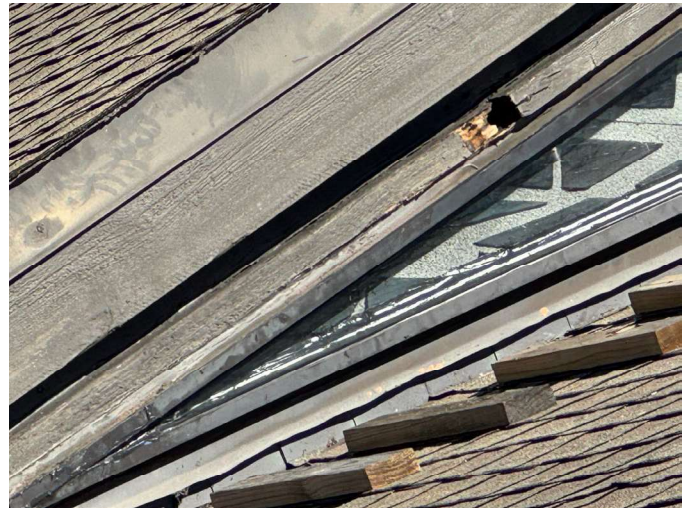
**Photograph 12.** Deteriorated wood trim was observed at isolated locations throughout the Sanctuary. All such distress should be repaired or replaced to return the facility to a fully serviceable condition; however, according to Binswanger personnel, all such repairs are outside the scope of their contract.

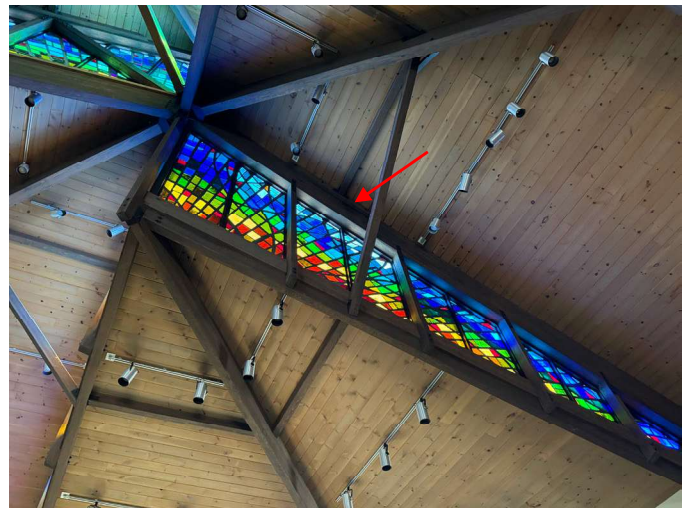
**Photograph 13.** According to Fr. Hawxhurst, previously reported leaks appear to have been corrected, except for one location where the leak appears to originate at the base of the steeple connection above the west lower clerestory. It is believed that proposed repairs to the steeple will address this leak.
